COMPLIANCE EVALUATION INSPECTION REPORT

INSTALLATION NAME: Equistar Chemicals, LP

EPA ID No.: ILD 048 296 180

DATE OF INSPECTION: May 31, 2017 – June 1, 2017

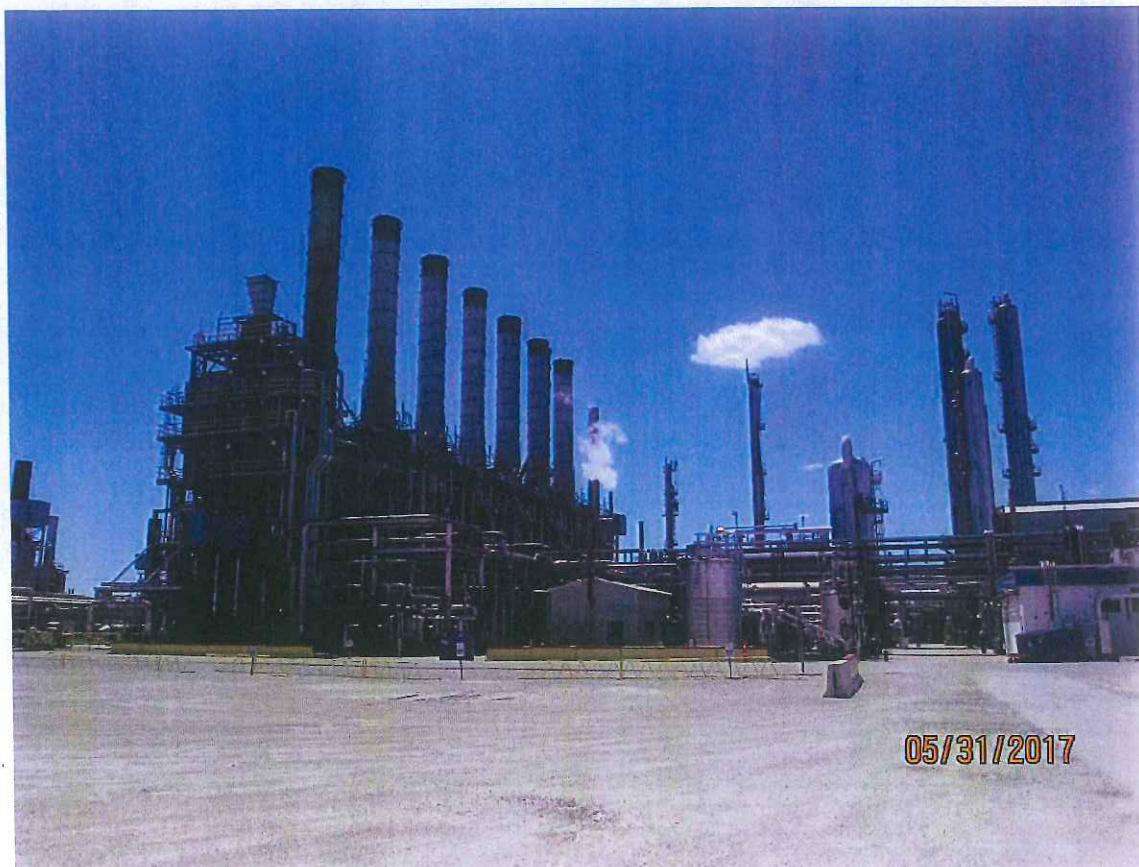
Photo 1. Photographer: G. Scambiaterra. Time: 2:25 p.m.
Description: West Side, Ethylene Mfg. Furnaces.

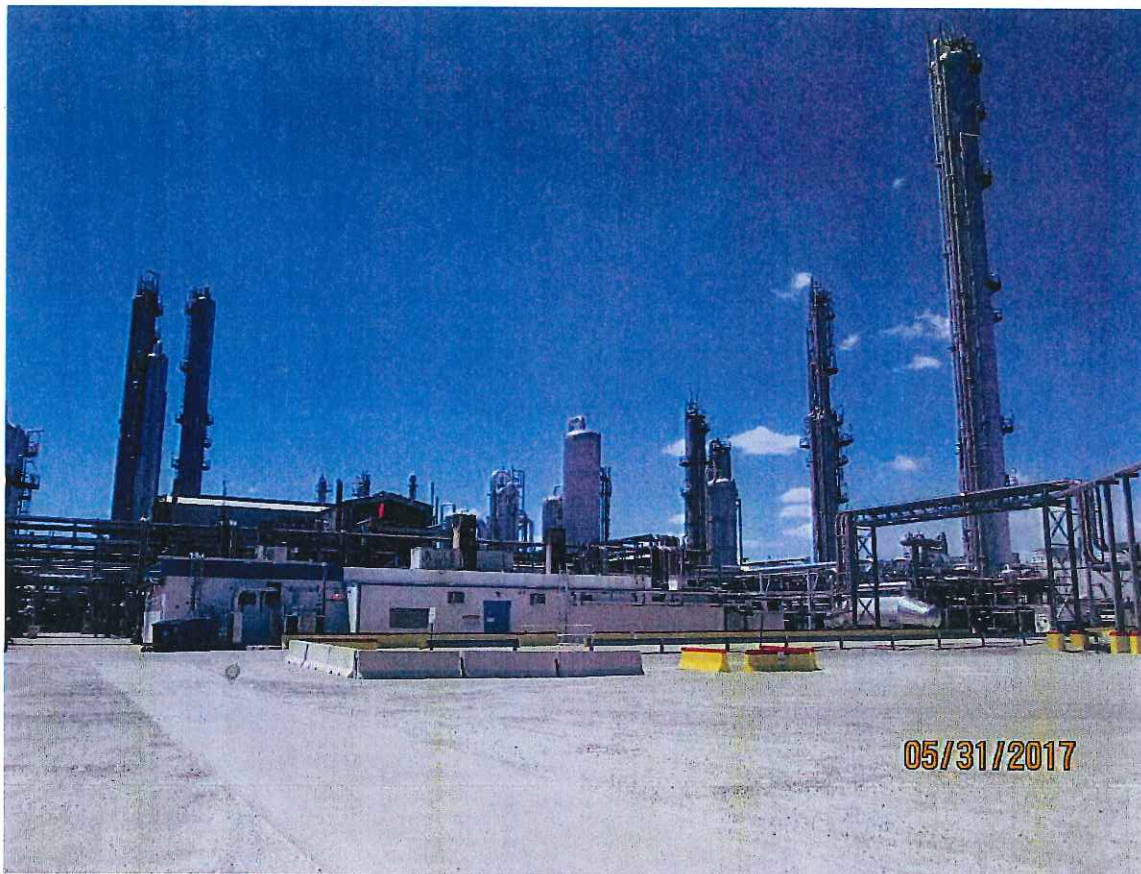
Photo 2. Photographer: G. Scambiatterra. Time: 2:26 p.m.
Description: West Side, Ethylene Mfg. C2 splitter (de-ethanizer), de-methanizer
refrigeration unit.

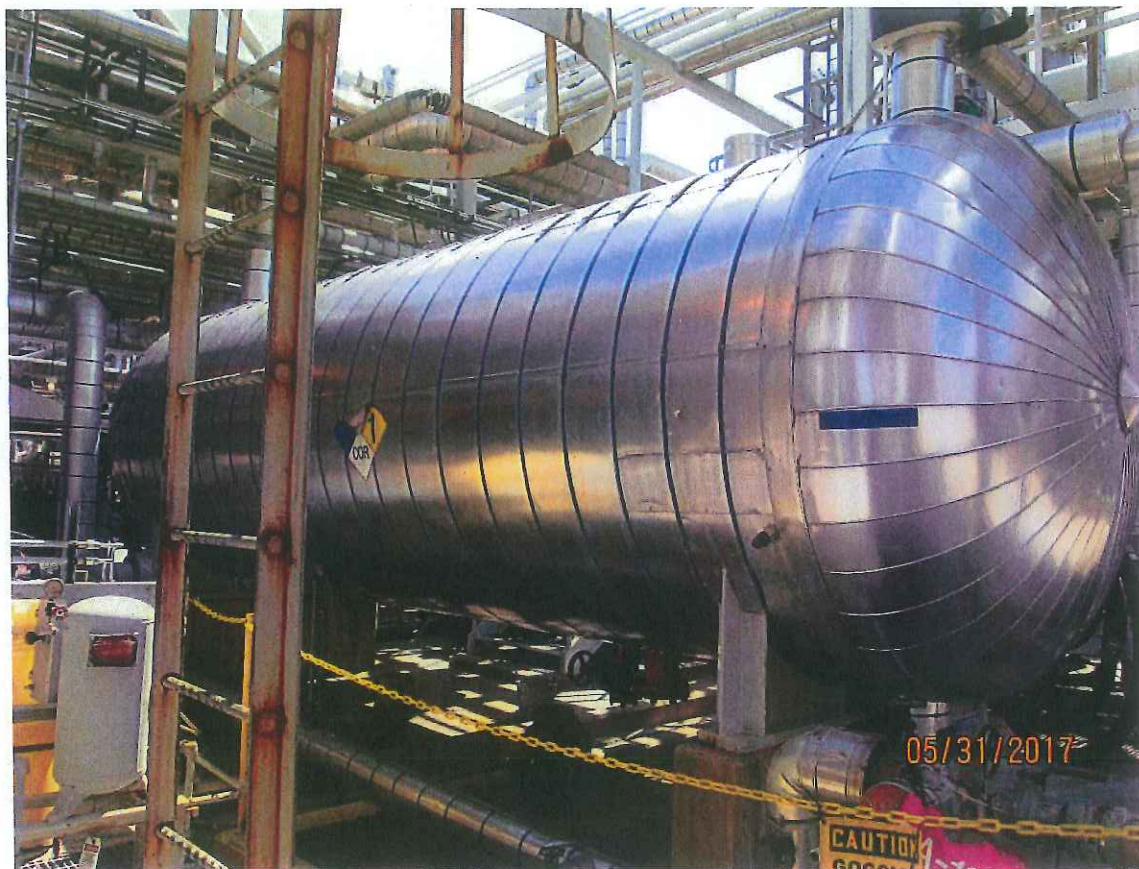
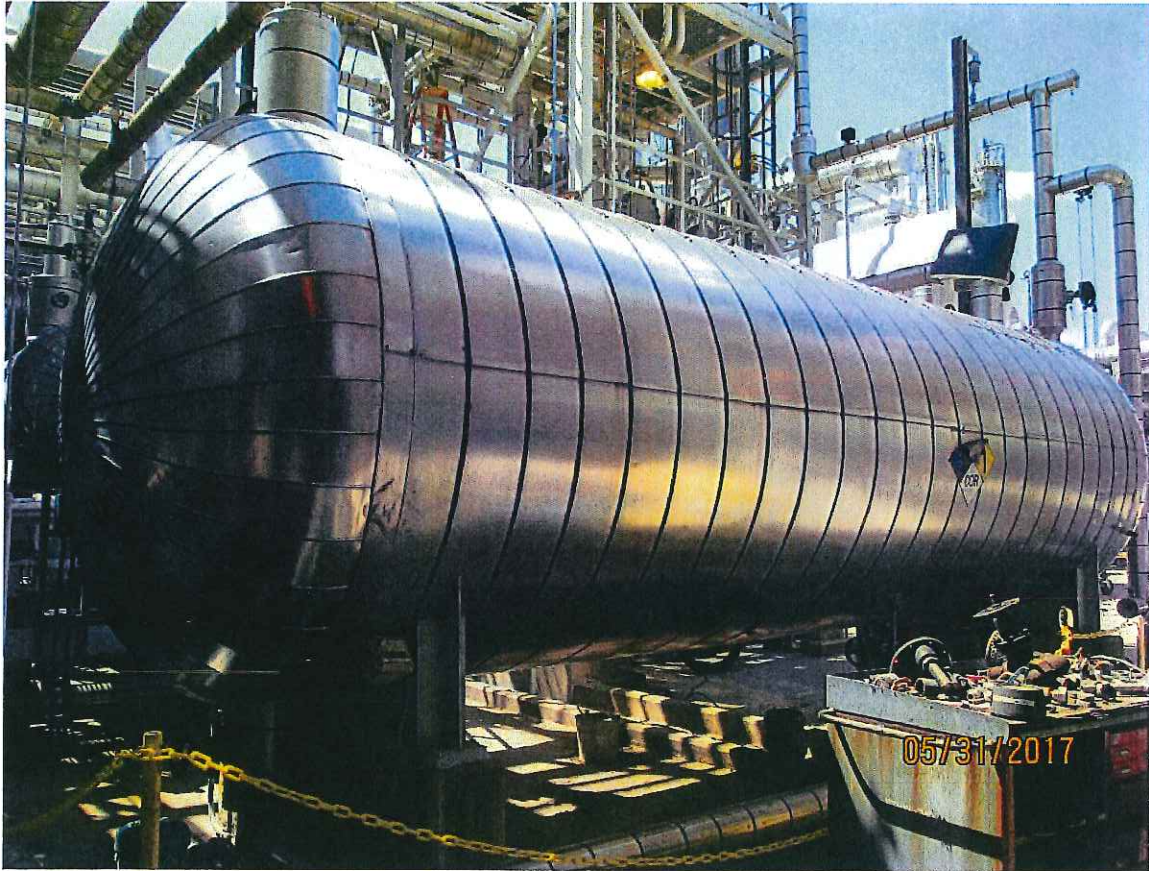
We walked around the west side area, up and down several levels, including the furnace area (*see* photos #1-2, overview of the west side). Within the west side, we inspected the caustic waste tank (FA-125), which is generated from the benzene stripper (*see* photos #3-5).

Photo 3. Photographer: G. Scambiatterra. Time: 2:49 p.m.
Description: West Side, FA125 tank.

Photo 4. Photographer: G. Scambiatterra. Time: 2:50 p.m.
Description: West Side, FA125 tank.

Photo 5. Photographer: G. Scambiatterra. Time: 2:50 p.m.
Description: West Side, FA125 tank.

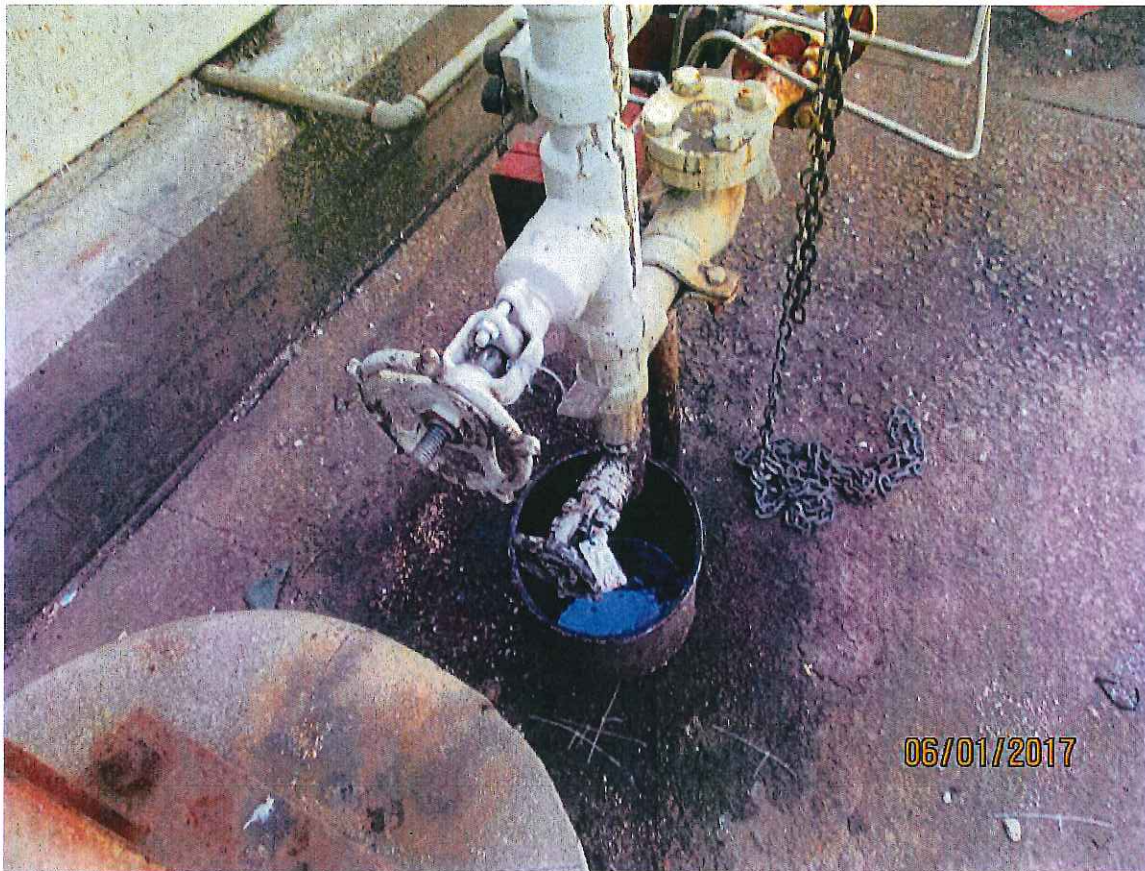
Also in this area, vinyl acetate (VA) is injected into one of the process lines (line 3) and into the primary compressor. Once the VA exits the compressor area, it's a hazardous waste. A VA knockout drum/vessel is used for the VA waste (*see* photos #6-8) prior to

Photo 6. Photographer: G. Scambiaterra. Time: 9:33 a.m.
Description: East Side, Polymer mfg. VA knockout vessel.

Photo 7. Photographer: G. Scambiaterra. Time: 9:34 a.m.
Description: East Side, Polymer mfg. VA knockout vessel valves.

Photo 8. Photographer: K. Bellairs. Time: 9:35 a.m.
Description: East Side, Polymer mfg. VA knockout vessel valves.

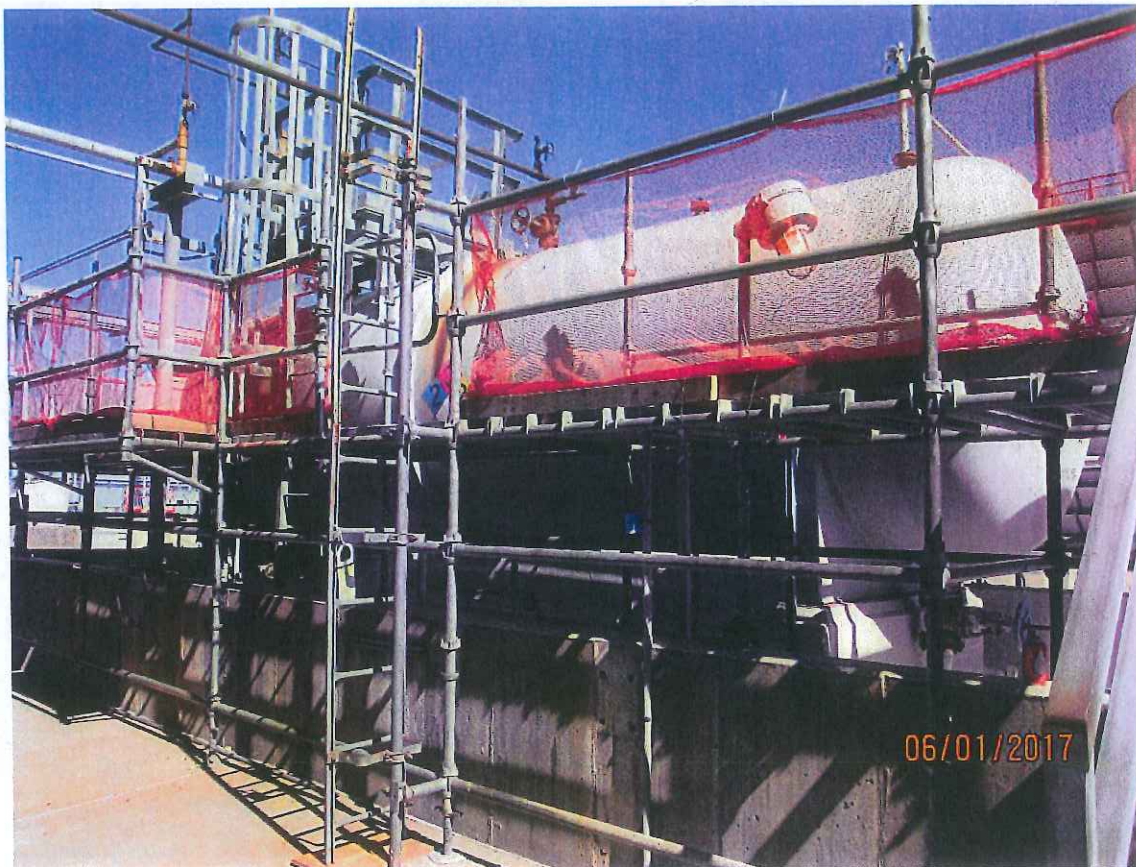
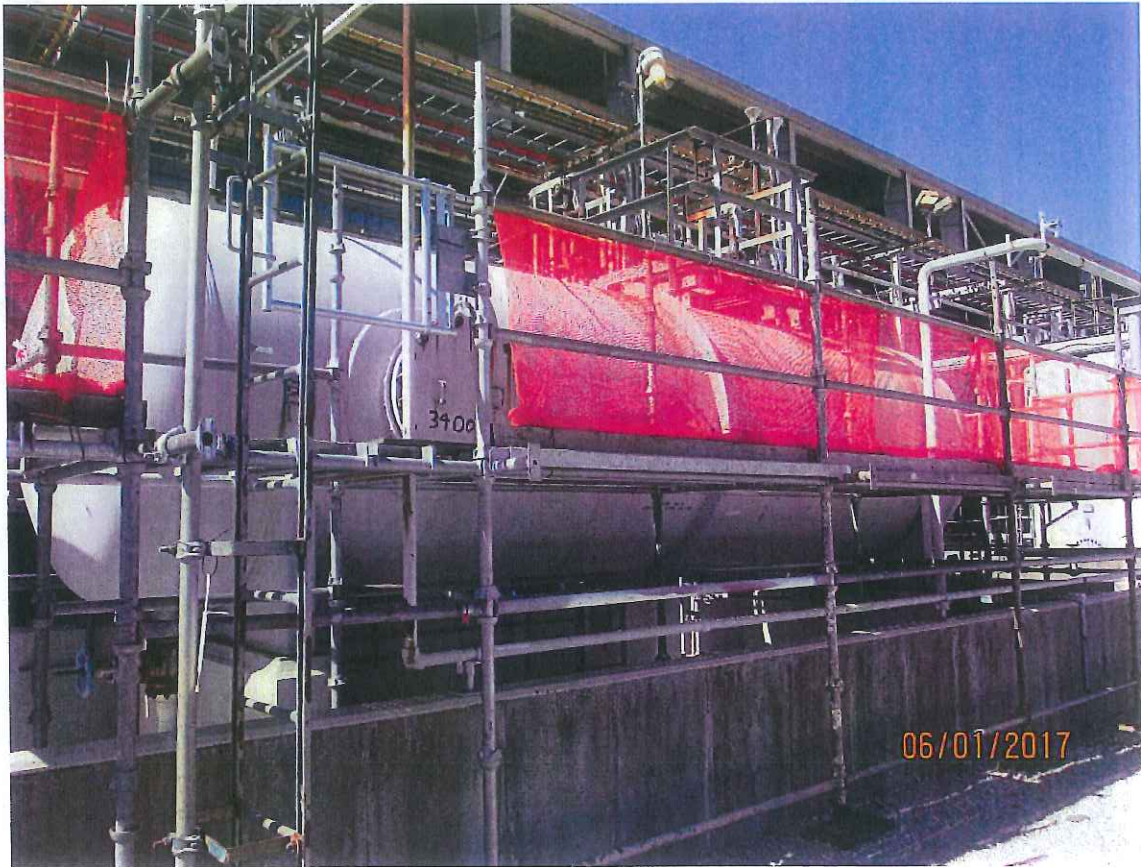
being sent to a hazardous waste storage tank (see photos #9-11). The VA waste is offloaded from the hazardous waste storage tank onto tanker trucks at the offloading area (see photo #12).

Photo 9. Photographer: G. Scambiaterra. Time: 9:40 a.m.
Description: East Side, Polymer mfg. VA waste storage tank.

Photo 10. Photographer: G. Scambiaterra. Time: 9:41 a.m.
Description: East Side, Polymer mfg. VA waste storage tank.

Photo 11. Photographer: G. Scambiatterra. Time: 9:41 a.m.
Description: East Side, Polymer mfg. VA waste storage tank.

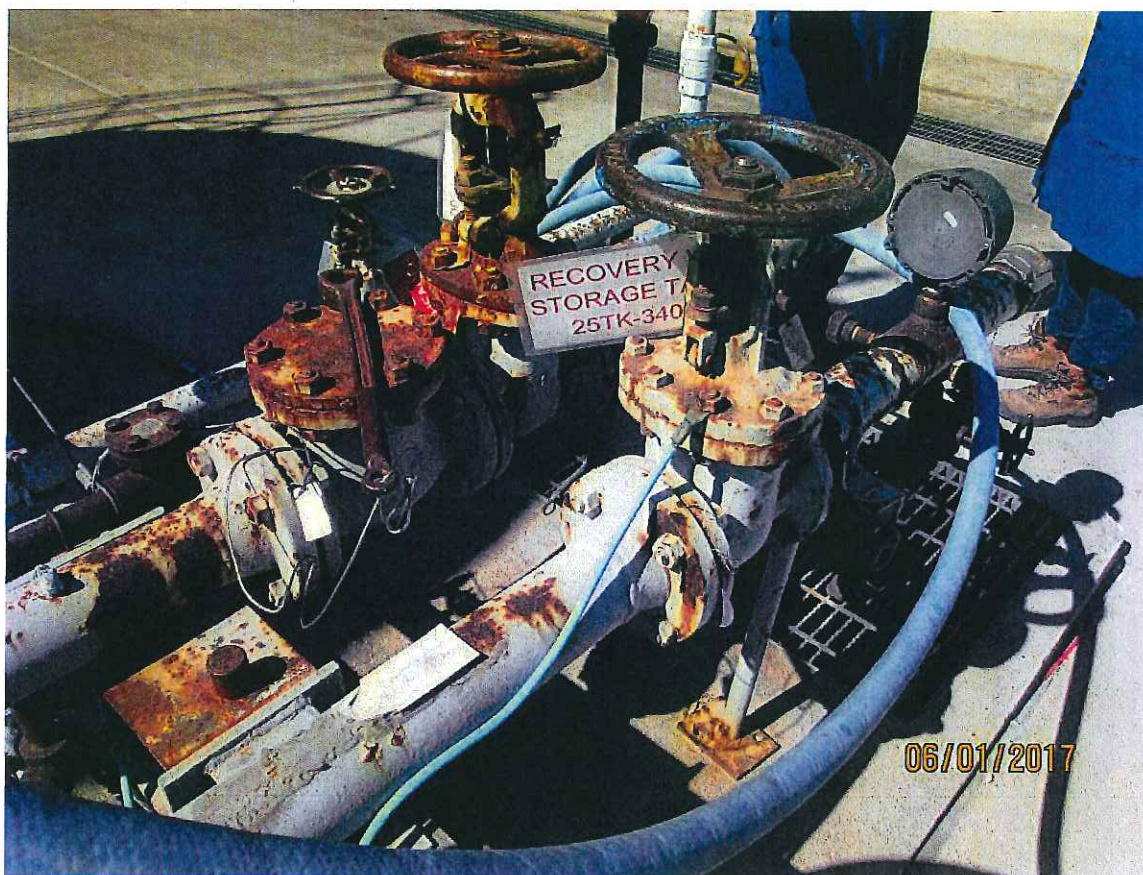
Photo 12. Photographer: G. Scambiaterra. Time: 9:44 a.m.
Description: East Side, Polymer mfg. VA waste storage tank offloading area.

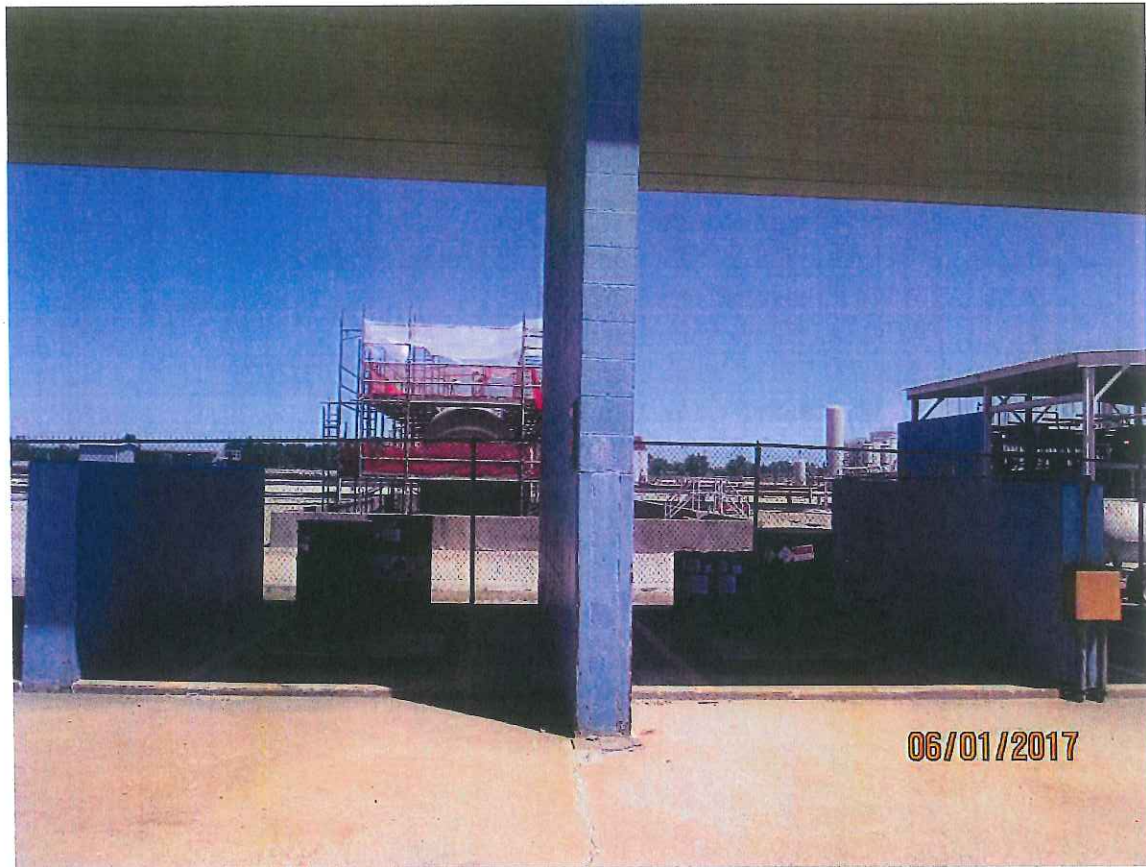
The final area we inspected was the hazardous waste container storage area. I noted eleven containers of hazardous waste within the storage bays (see photo #13). The oldest container in storage was dated 1/17/2017. Mr. Popodisnki informed me that he conducts the weekly inspections of this area every Wednesday.

Photo 13. Photographer: G. Scambiaterra. Time: 11:21 a.m.
Description: Container storage area/Handling Area. Containers of hazardous waste.
